## ENVIRONMENTAL ASPECTS OF POST MINING URANIUM WASTES DEPOSITED IN RADONIOW, POLAND

**Abstract:** Post mining uranium wastes from Radoniów were analysed and chemical, mineralogical and petrographic characteristics were performed. Additionally, the size parameters of dumps and direction of water runoff were estimated using LIDAR data. Bioaccumulation of uranium in different plants covering dump's surface was shown.

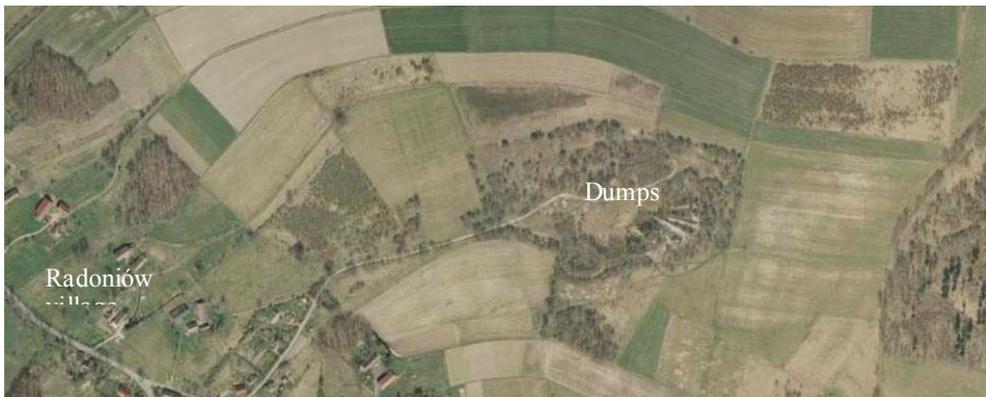
Fig. 1. Post mining waste in the dumps in Radoniow ([www.geoportal.gov.pl](http://www.geoportal.gov.pl))

Waste dumps in Radoniow are localized in the vicinity of Radoniow village and they are surrounded by agricultural lands (Fig. 1). The surface of dumps is is tightly folded (especially the surface of the large dump) and clear signs of erosion are visible (Fig. 2).
